MEADOW GROUNDS DAM,

(NDS LD. <sup>Number</sup> PA - 00185,

Potomac River Basin, Roaring  
Run, Fulton County, Pennsylvania

PHASE I INSPECTION REPORT.  
NATIONAL DAM INSPECTION PROGRAM

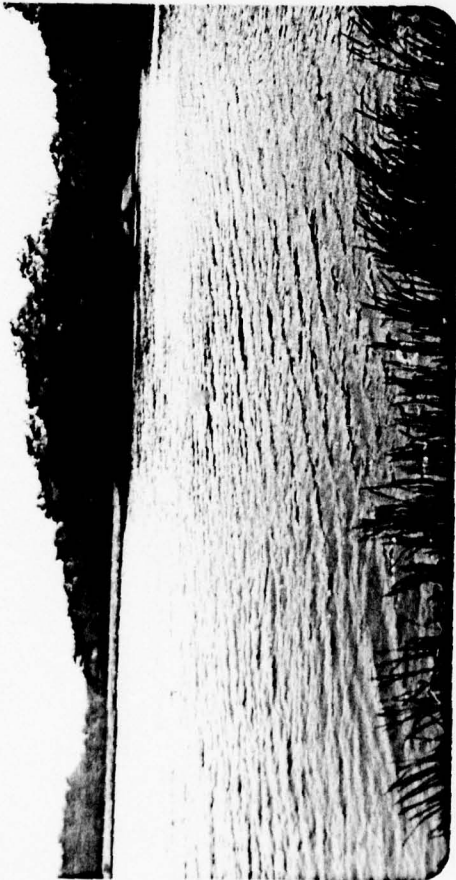
2. Outlet Works. Visible portions of the outlet works were found to be in good condition (see Photographs 9, 10, and 11). No concrete deterioration was noted on the control riser or outlet endwall. The interior of the outlet conduit was not inspected because of partial inundation and noxious conditions attributed to the stagnant pool at the outlet (see Photograph 11). The stoplogs were in place and functioning as designed.

PHOTOGRAPH 9 View showing top of control riser and hand-placed riprap.
